Docket No. 217 – Development and Management Plan Inspection

Northeast Utilities Service Company Certificate of Environmental Compatibility and Public Need for the construction of a 345-kV electric transmission line and reconstruction of an existing 115-kV electric transmission line between Connecticut Light and Power Company's Plumtree Substation in Bethel, through the towns of Redding, Weston, and Wilton, and to the Norwalk Substation in Norwalk, Connecticut.

Date: December 22, 2005

Location: 115 kV Underground Route

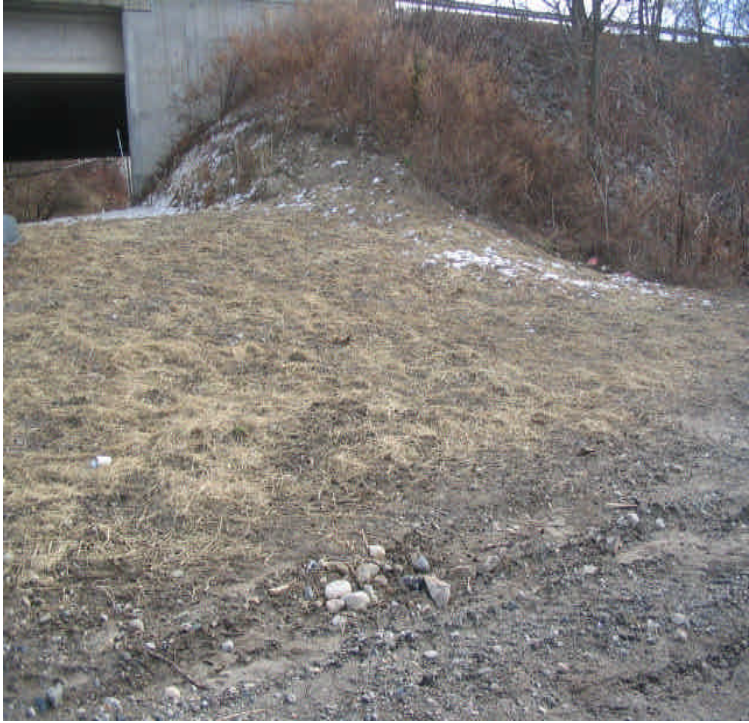
115kV (ROW): Photo on the left shows the slope which was mulched prior to snow cover. Most snow cover has since melted. Photo on the right shows some work building the scaffolding at a structure near the substation. 12/22/05

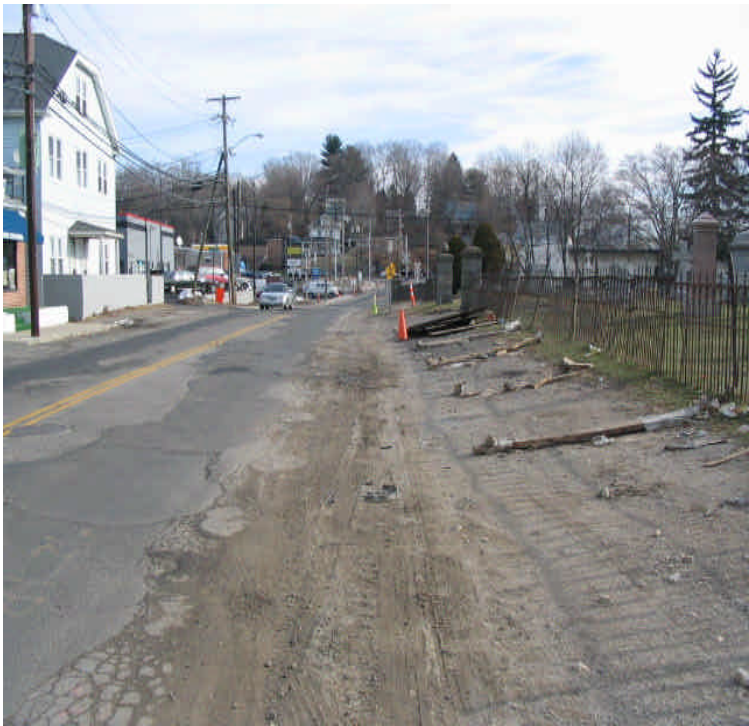
Areas of Inspection	Observation	Recommended Action
Broad Street/ROW, Norwalk	- A few materials were left behind along the side of the roadway but most areas were mulched prior to snow cover. 12/22/05	-General cleanup should be performed and the road surface is still fairly rough. 12/14-12/22/05
Broad Street/ROW, Norwalk	- The bike path in the ROW will not be constructed until spring. 12/22/05	- None at this time. 12/22/05
Main Ave. / Rt. 7, Norwalk	- Scaffolding was being built for structure work near the substation. 12/22/05	- None at this time. 12/22/05
Main Ave. / Rt. 7, Norwalk	-115kV work apparently associated with the structure at Norwalk Junction required snow plowing on site. Some issues resulted that need attention. 12/14-12/22/05	-See erosion control section for details but repairs are necessary. It will have to be worked out between contractors. 12/14-12/22/05
Erosion and Sediment Controls (includes inspection within 24 hours of a storm event)	- The northern ROW was placed with stone for equipment access but some portions were somewhat rutted. 12/1-12/22/05	-Some mulch should be placed on ruts when access needs are complete. Snow and thaw periods are now a factor.12/8-12/22/05

115kV (Broad St. and Norwalk Junction): Photo on the left shows Broad St. where some materials remain along the roadside. Some general cleanup here may be necessary. Photo on the right is the view of the snow pile remaining at Norwalk Junction. Responsibility for silt fence repair needs to be determined between contractors. 12/22/05

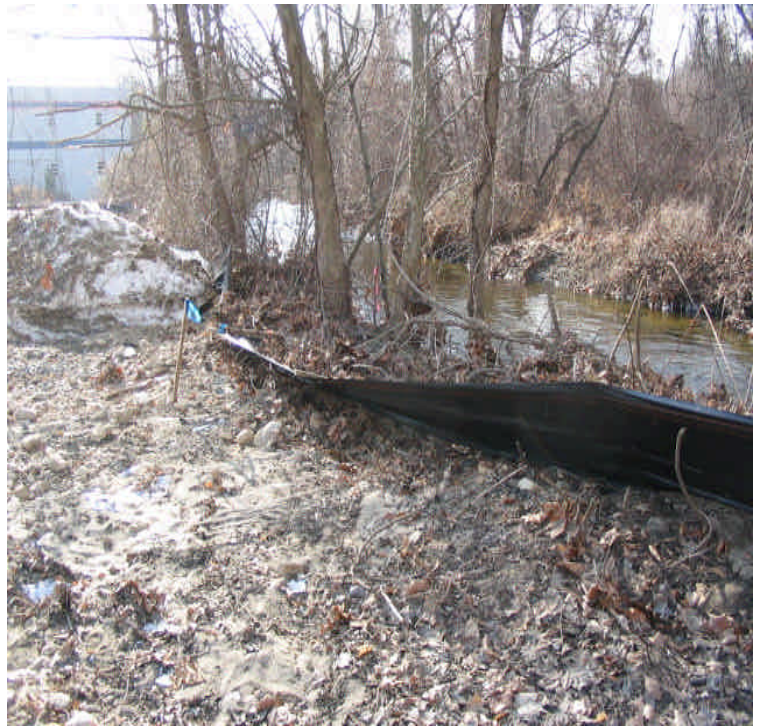
Areas of Inspection	Observation	Recommended Action
Main Ave/ Rt. 7, Norwalk	-Erosion controls were pushed over as a result of the snow plowing at Norwalk Junction- apparently for 115kV related work on the structure. This has pushed sediment laden snow towards the river beyond the silt fence. 12/14-12/22/05	- The 115kV contractors should repair the fence and pull back the snow piles if it is determined to be their responsibility. This should be worked out among the contractors. 12/22/05
Contaminated Soils	-Clean process remains in one pile at the Putnam Park storage area. Clean soil was spread at the Rt. 107 and Sunset Hill storage areas. 12/22/05	- All soils appear to be handled appropriately. 12/22/05
Adjacent Wetlands and Waterways	-The stream near Sara's Way off Rt. 58 remains clear and banks are free from erosion. 12/22/05 - A small stream crossing near Putnam Park at a vault also remains clear at this time. 11/23-12/22/05 -Some soil was accidentally pushed into the wet swale adjacent to the storage yard on Sunset Hill Rd. 12/22/05	- None at this time. Continue to monitor for final vegetative stabilization. 12/22/05 - Monitor as bare soil remains around the stream. A few haybales could be installed. 12/22/05 - Shovel back soil if feasible and install erosion controls until the next growing season. 12/22/05

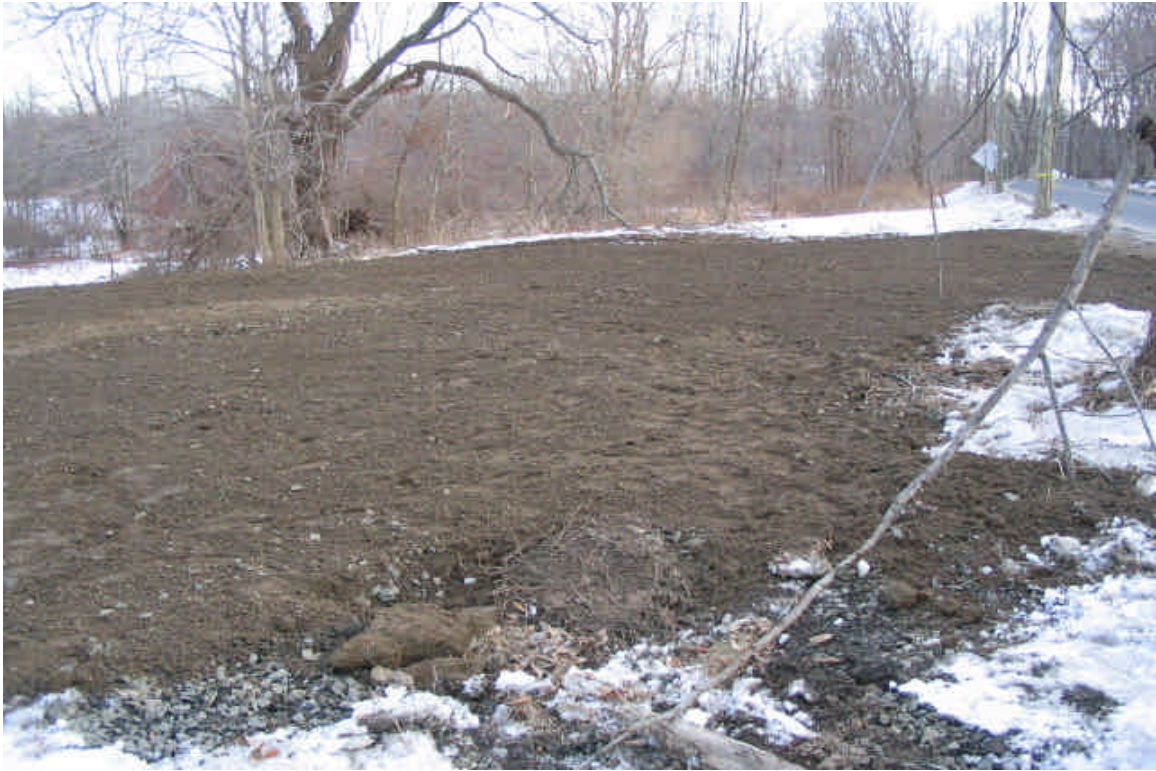
Rt. 107 (Lonetown Rd)	- The storage area south of the 90 degree turn on Rt. 107 was also graded and placed with topsoil. Erosion controls were also removed here but we recommend that they should remain due to the more extensive area of disturbed soil. 12/22/05	- Since there will be no chance of vegetative stabilization until the growing season, we recommend that that toed in silt fence or haybales remain here or the area should be well mulched immediately due to the wetland area at the base of the slope. 12/22/05
Broad Street and ROW, Norwalk	- A disturbed area near the cemetery could use some mulch if feasible. 12/8-12/22/05	- Leftover materials should also be picked up. 12/14-12/22/05

115kV (Rt. 107 storage yard). Photo shows the storage area near the Rt. 107 90 degree turn which has been graded and placed with topsoil. Due to the time of year and lack of any chance of vegetative stabilization, we recommend leaving haybales or silt fence if it can be toed-in 12/22/05

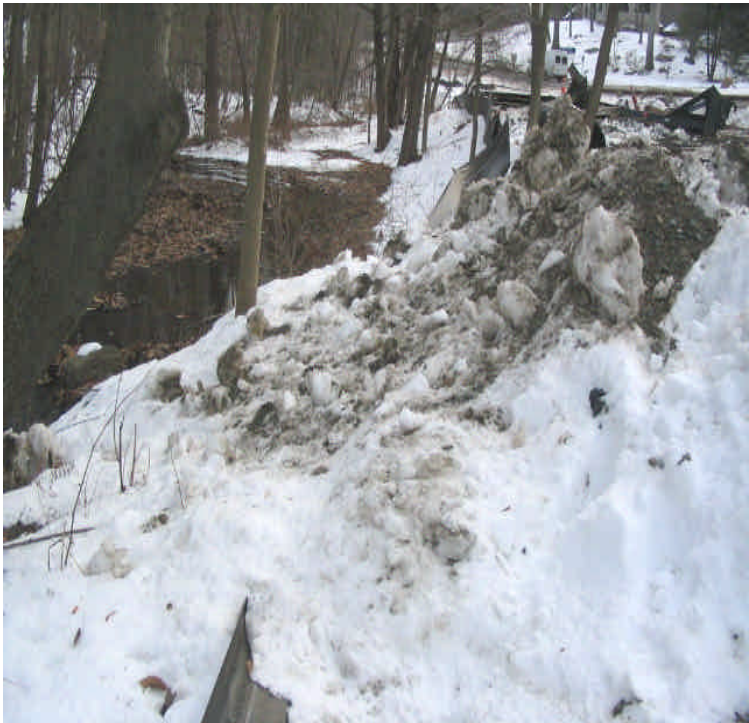
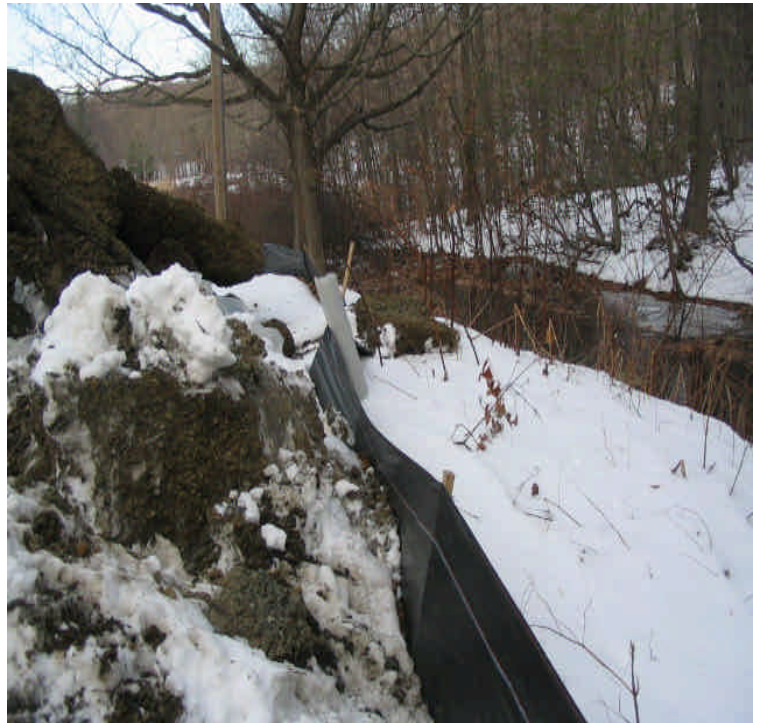
- Snow plowing at the Putnam Park storage area created some issues as sediment laden snow was pushed beyond the controls towards the stream. 12/14-12/22/05	-Pull back snow from the wetlands and repair the silt fence. Future plowing should be done with care. Toed-in perimeter fence or haybales should remain at this site until the growing season at this point. 12/22/05
	-The Sunset Hill Rd. storage area was graded and topsoil was placed. Unfortunately, the soil was pushed into the wetland swale at the yard's edge and erosion controls are not in place. 12/22/05	- There will be no chance of vegetative stabilization until the growing season, we recommend that that silt fence or haybales remain here- or the area should be well mulched immediately. Soil should be shoveled out of the swale if feasible. 12/22/05
Gallows Hill Road	-The roadway and adjacent work areas are well stabilized. 12/22/05	- None at this time 12/22/05

Staging, Storage, and Parking Areas	- At the storage area off Rt. 58 near Putnam Park controls were pushed over by sediment laden snow plow piles in some locations. 12/14-12/22/05 - The Sunset Hill Rd. and Rt. 107 storage yards have been graded and placed with topsoil and are no longer in use. However, the amount of disturbed soil left behind warrants additional attention. 12/22/05	-Snow needs to be pulled back and erosion controls repaired. Retain the silt fence here due to the proximity of the pond. 12/14-12/22/05 - Since disturbed soil remains and there is no chance of re-vegetation until the growing season, we recommend haybales or other erosion controls. The areas were not mulched prior to pulling the silt fence. 12/22/05
State species of concern, threatened and endangered species	- No species of concern are located in the areas of construction.	- N/A
Vegetative clearing limits (including trees to save or	- A few areas as noted had ruts caused by equipment access. They should be re-restored when	- The D&M plan requires that disturbed areas that will be left for more than 21-30 days

115kV (Putnam Park Storage Area) Photos show various views of the snow plow piles and associated sediment that were pushed over the silt fence. These should be pulled back and the silt fence restored due to the adjacent wetlands. 12/22/05

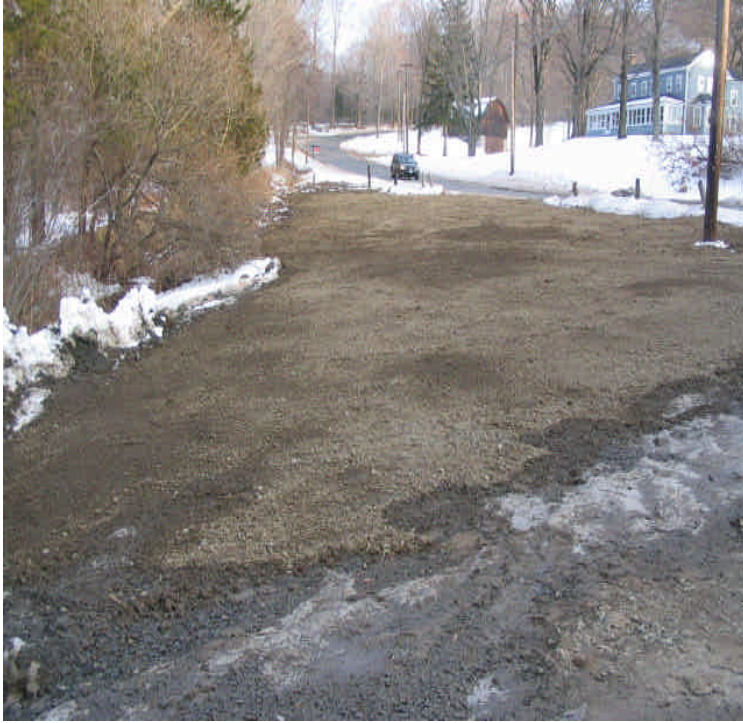
115kV: (Sunset Hill Rd. Storage Area) Photo on the left show where the storage area here was also graded and topsoil was placed. Photo on the right shows where this soil was accidentally pushed into the adjacent wetland swale. The soil should be pulled back and we recommend haybales until the area can stabilize in the growing season. 12/22/05

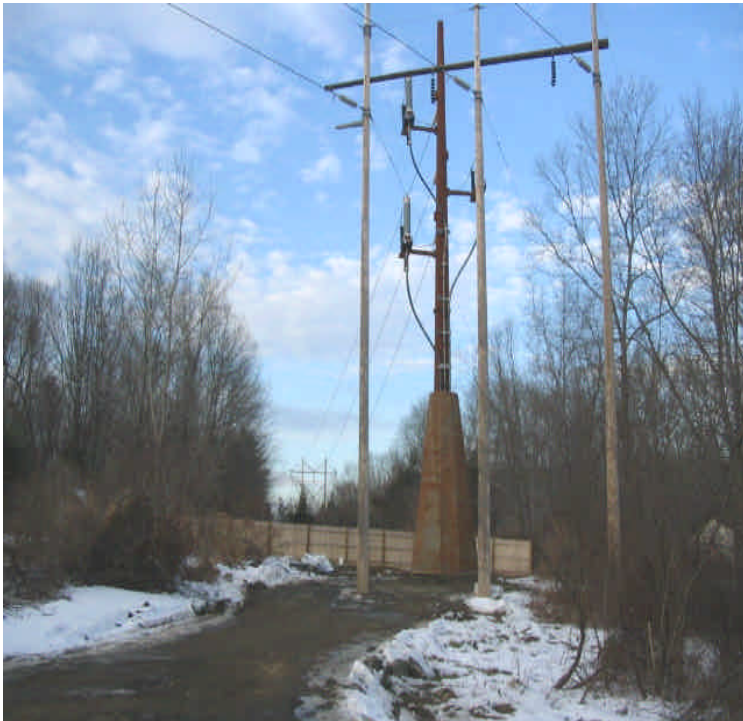
115kV: (Hoyts Hill) Photo on the left shows the completed work at the structure. Photo on the right shows the pre-existing drainage patterns returning across the access drive. 12/22/05
